FINAL REPORT  
JANUARY 1998

REPORT NO. 96-03

BULLPUP  
CHEMICAL OVERPACK  
CONTAINER EVALUATION

Prepared for:  
U.S. Army Chemical and Biological  
Defense Command  
ATTN: AMSCB-CMO  
Aberdeen Proving Ground, MD 21010-5423

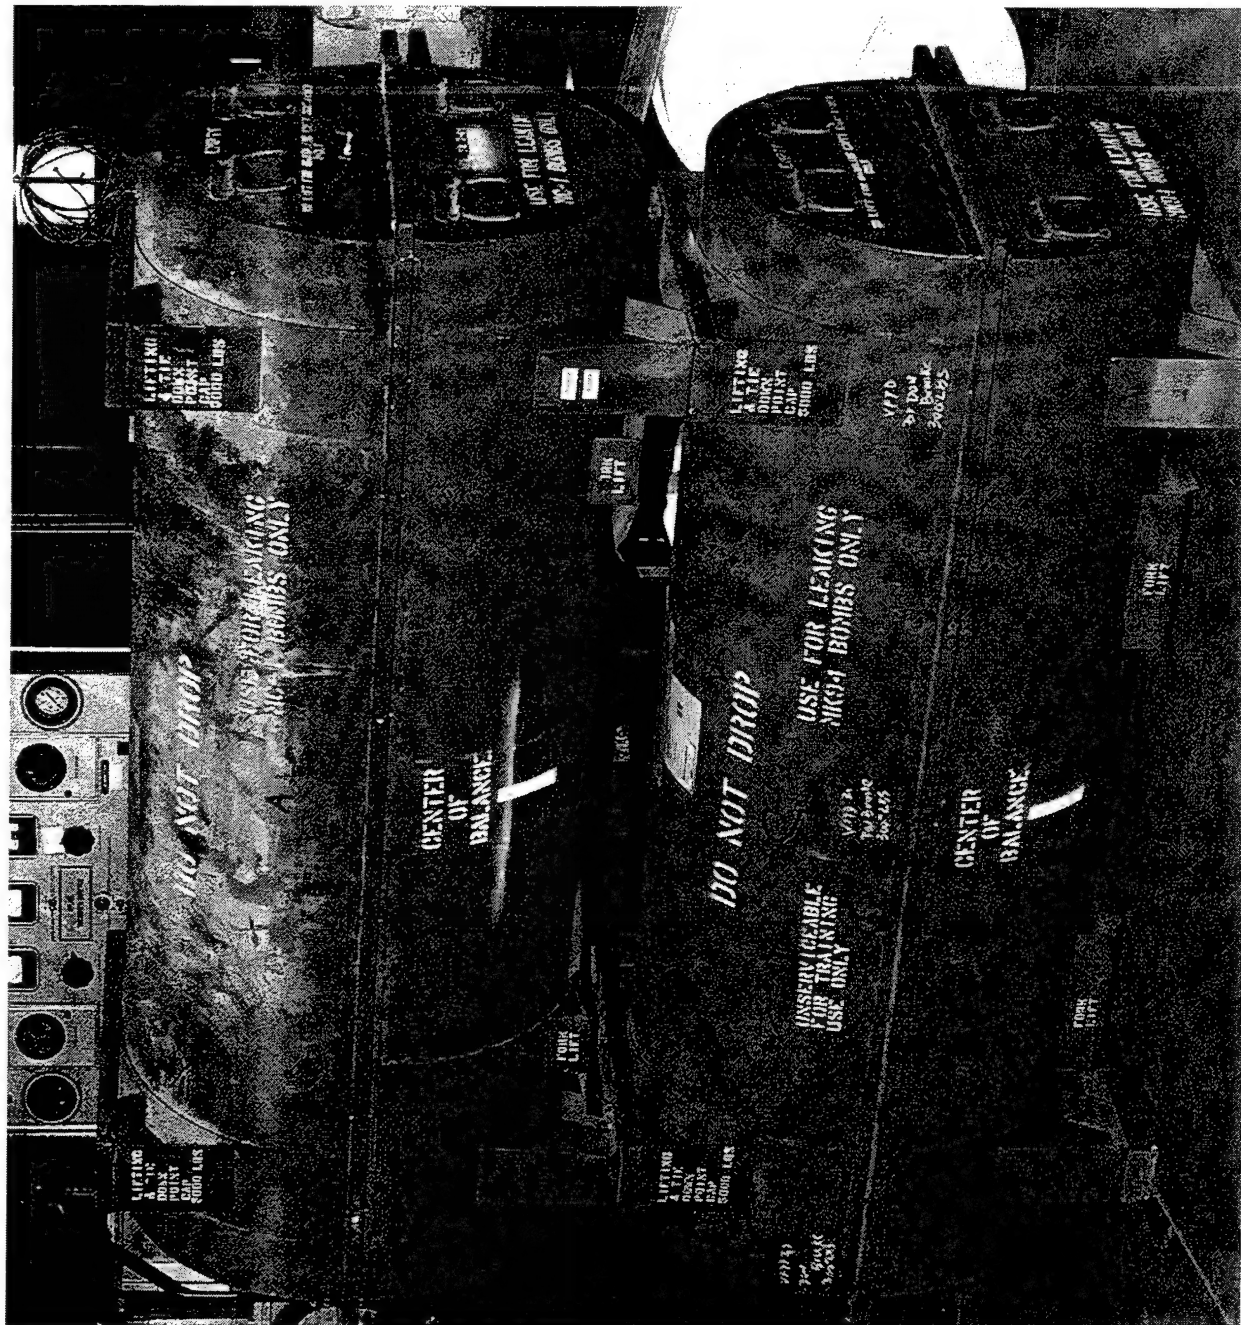
PHOTO NO. A0317-SCN98-DEVOVPK01.TIF. This photo shows an overview of the two BULLPUP containers used in the evaluation.

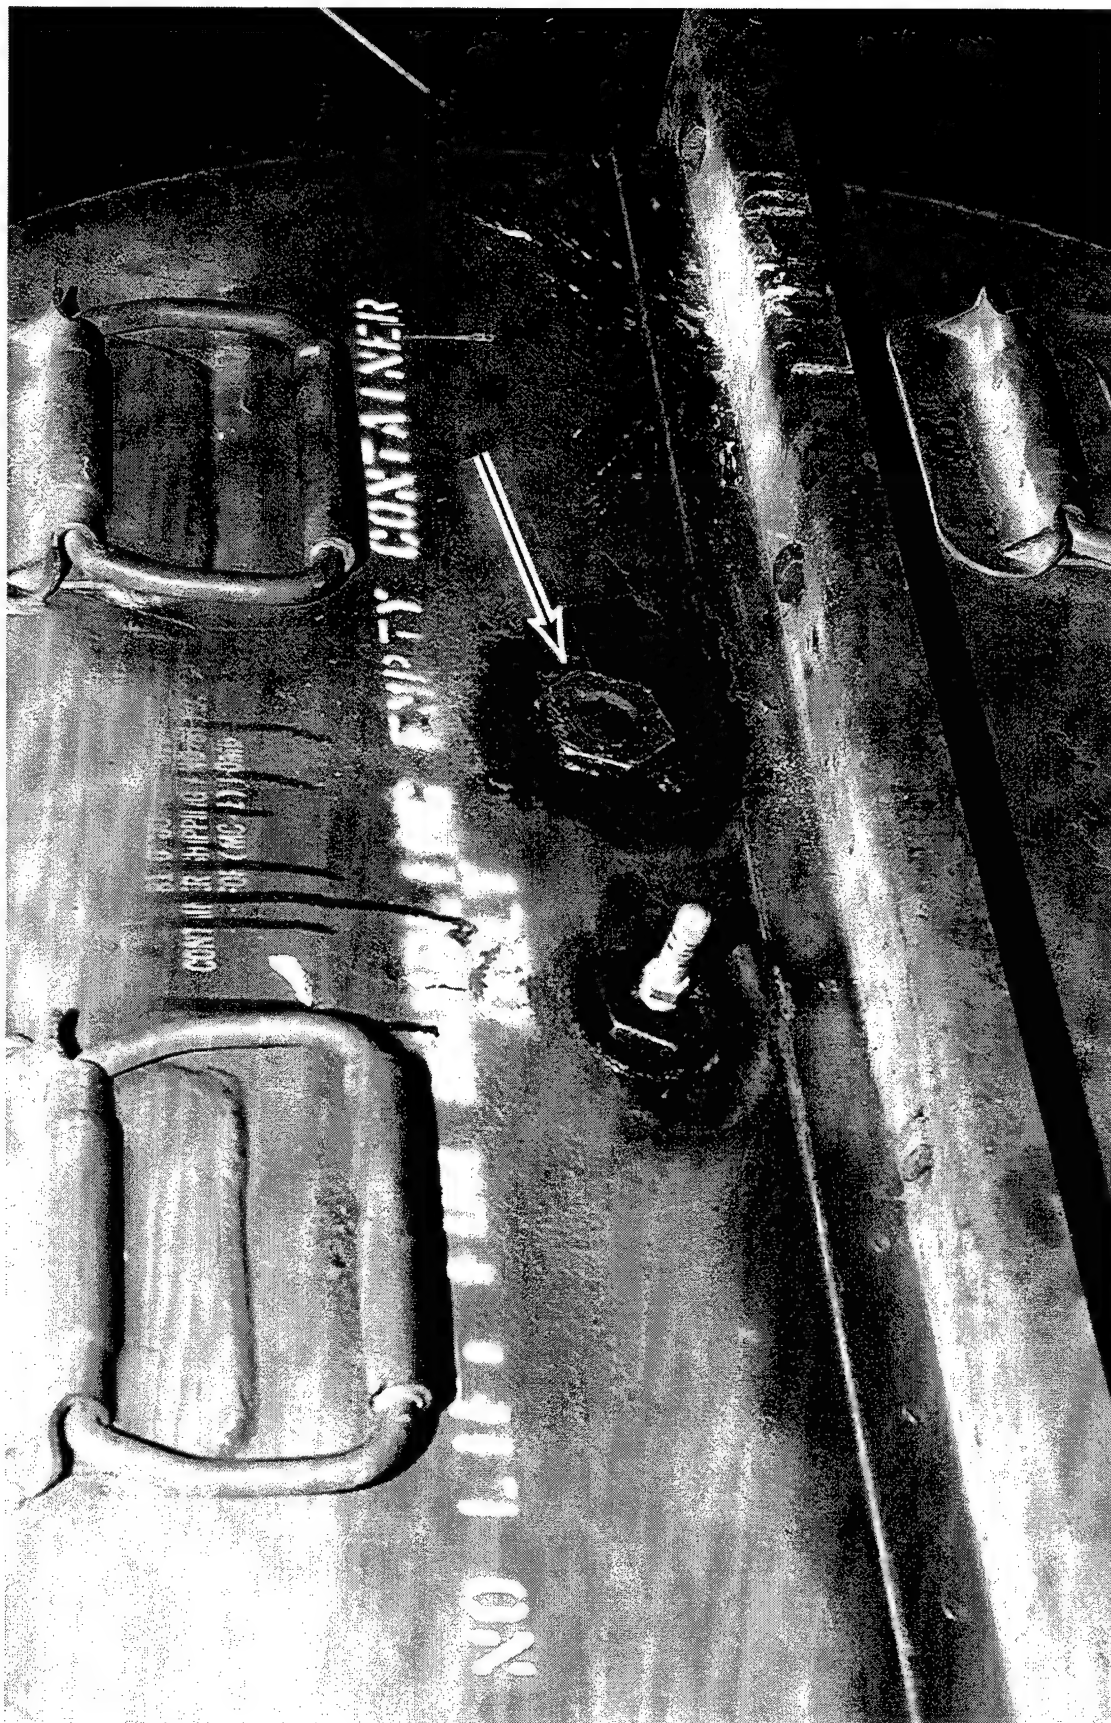
U.S. ARMY DEFENSE AMMUNITION CENTER - SAVANNA, IL	PHOTO NO. A0317-SCN98-DEVOVPK8.TIF. The arrow indicates the humidity indicator cover. A butyl rubber washer is placed over the threads. Butyl rubber sealant was also placed on the threads prior to installation.
---	--

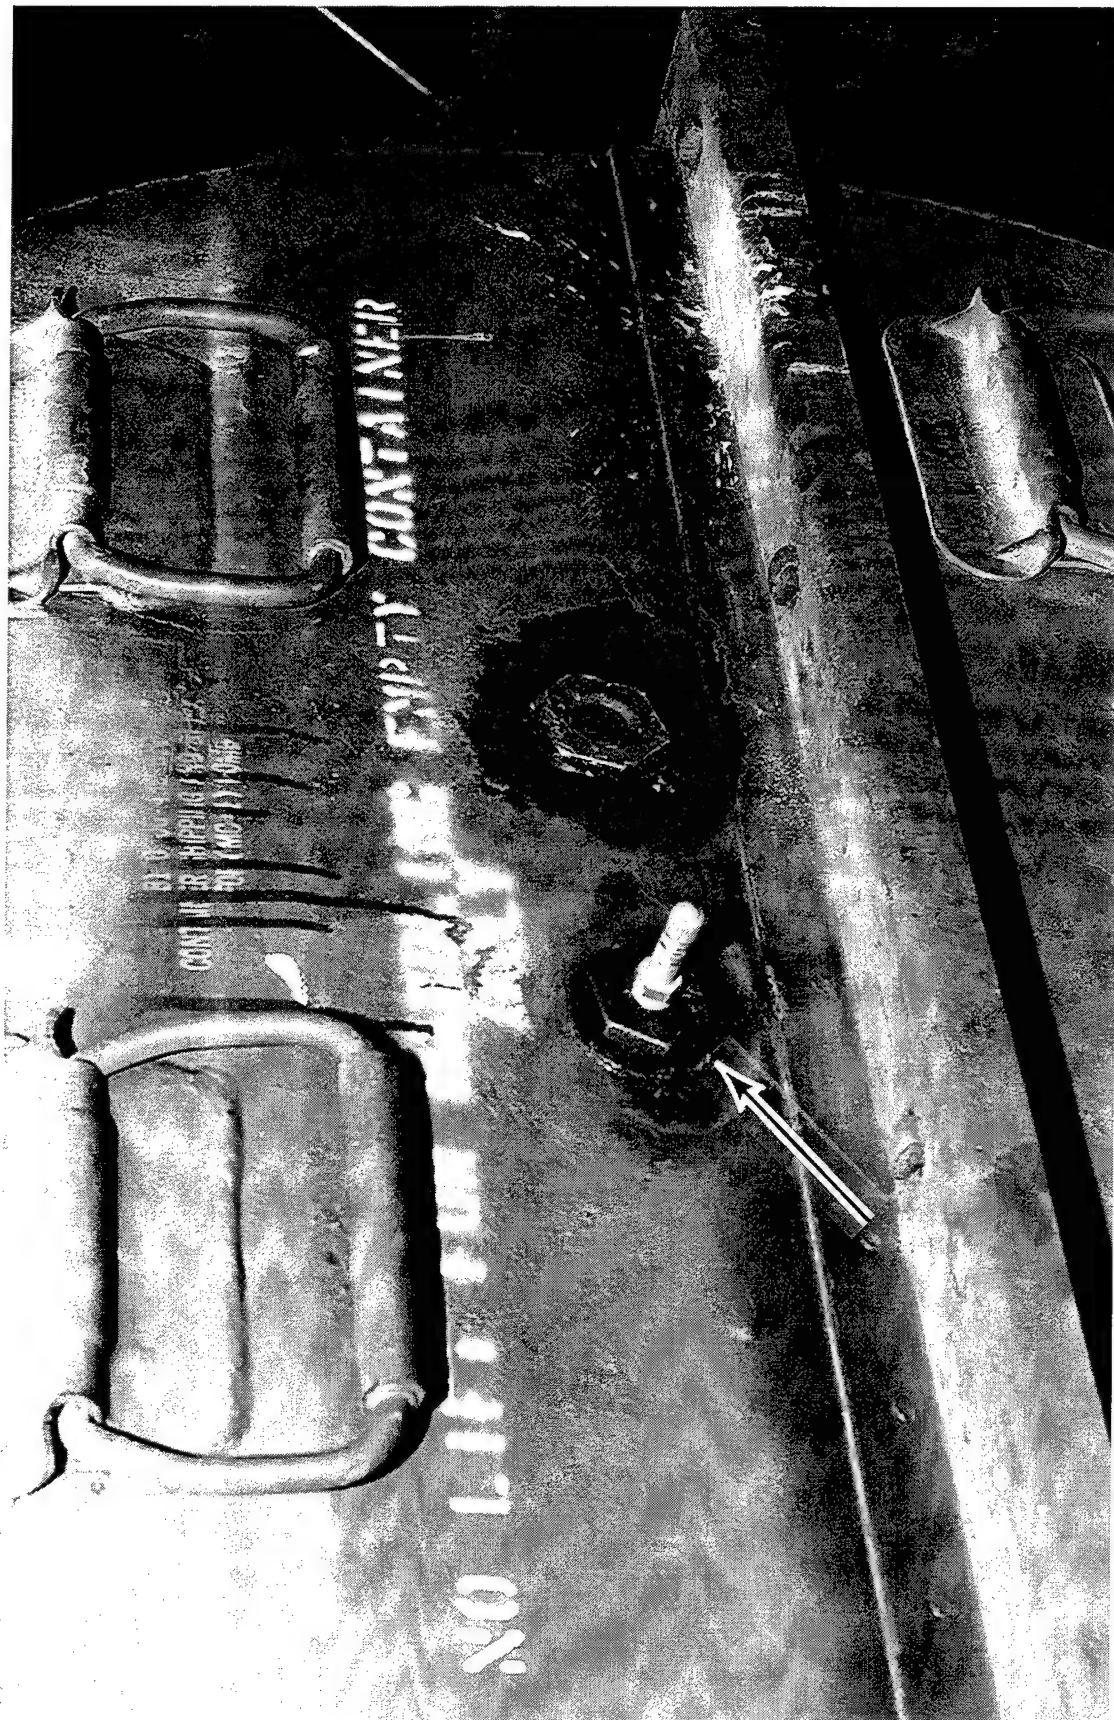
PHOTO NO. A0317-SCN98-DEVOVPK8.TIF. The arrow indicates a threaded plug with a shraeder valve installed. The plug had a butyl rubber washer and butyl rubber sealant placed on it prior to installation. The shraeder valve threads were covered with Teflon prior to installation.

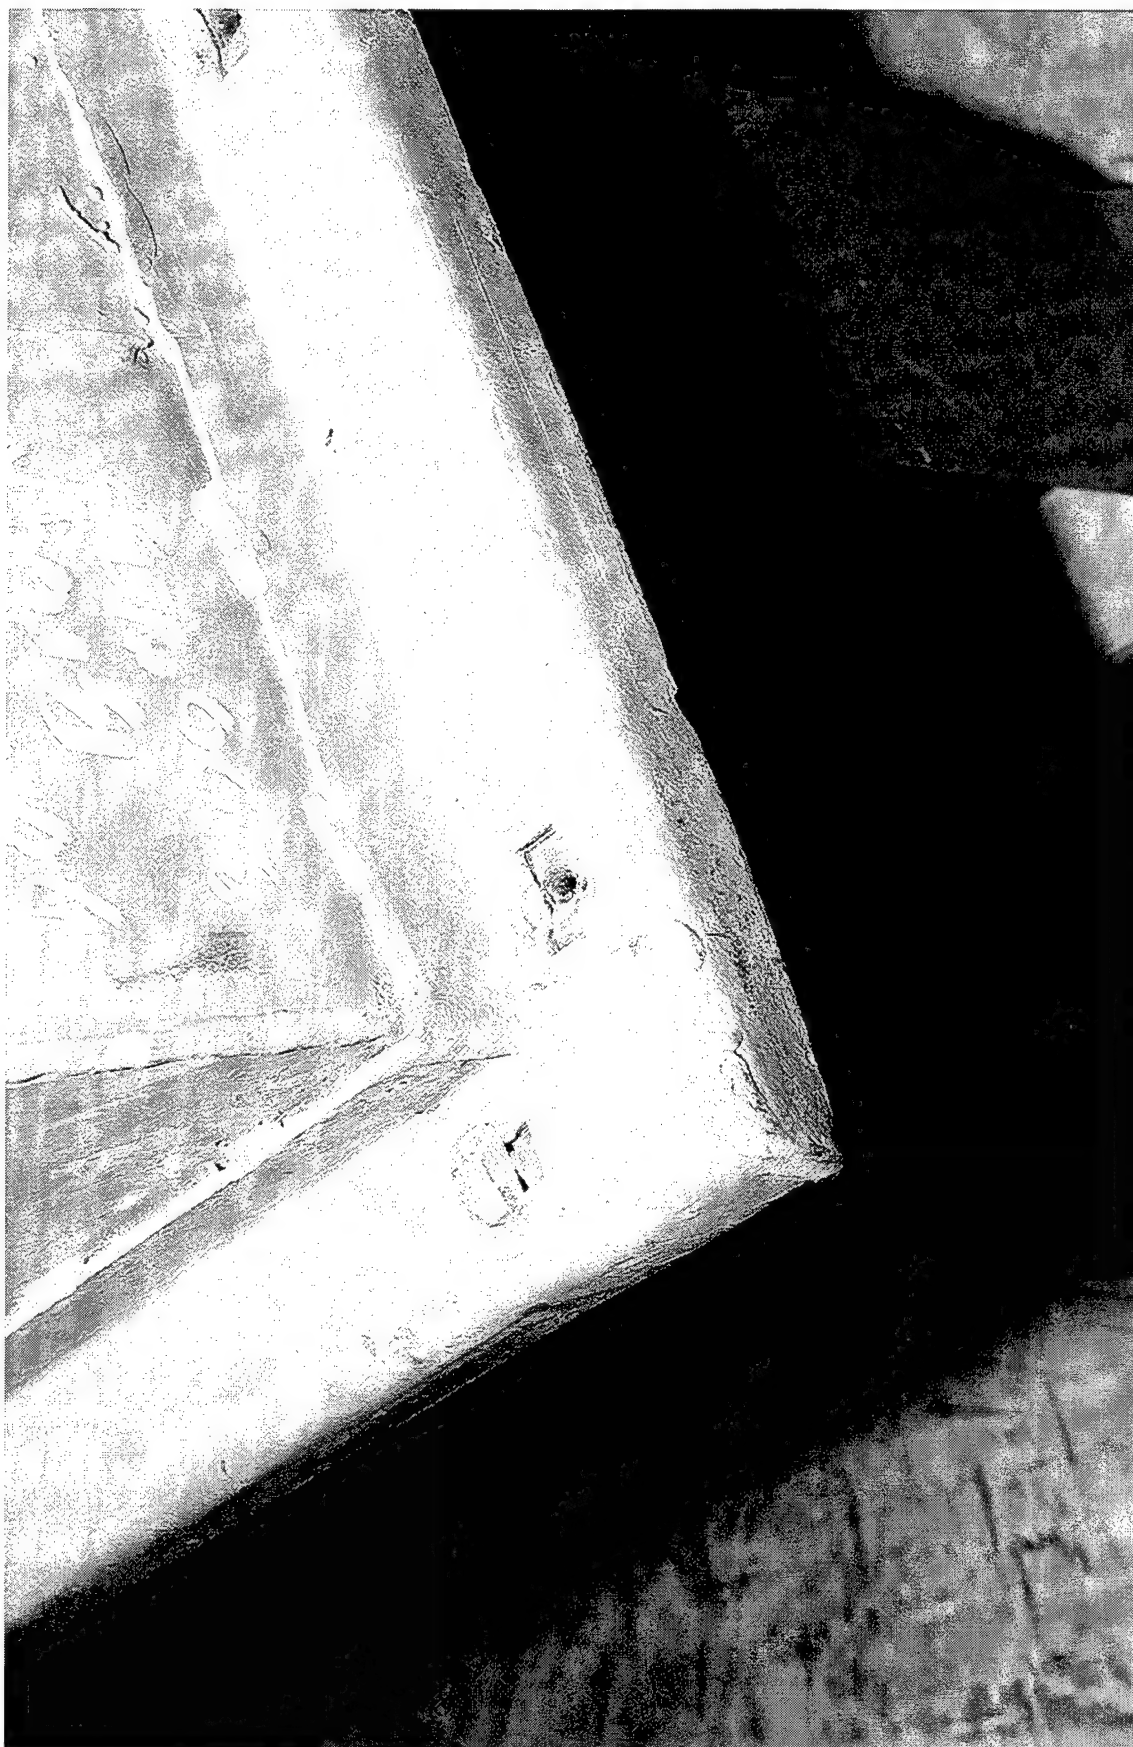
A visual inspection of the two BULLPUP containers was performed prior to testing. Container No. 1 was marked "Serviceable." It appeared to be in generally good condition. Small indentations existed in the flange, apparently caused by excessive torque applied to the Tee-bolts. Container No. 2 was marked "Non-serviceable." The flange had also been damaged, apparently from excessive force applied to the Tee-bolts during previous use.

As previously stated, each BULLPUP container has small indentations in the flange caused by excessive torque applied to Tee-bolts during previous applications. The indentations existing in the flange prior to the testing made it difficult to determine the exact torque that resulted in permanent deformation of the flange. At 200 in-lbs, visual inspection did not identify any permanent deformation to the flange of the containers. A torque of 250 in-lbs appeared to cause minimal permanent deformation of the flange. At 300 in-lbs, permanent indentations occurring in the flange were easily identified.

PHOTO NO. A0317-SCN98-DEVOVPK7.TIF. This photo shows the indentation in the container flange resulting from excessive torque applied to the Tee-bolts.

E. RECOMMENDATIONS. The Tee-bolts currently utilized should be tightened to a torque of 200 +/- 5 in-lbs. The humidity indicator or the breather valve can be replaced by a plug in

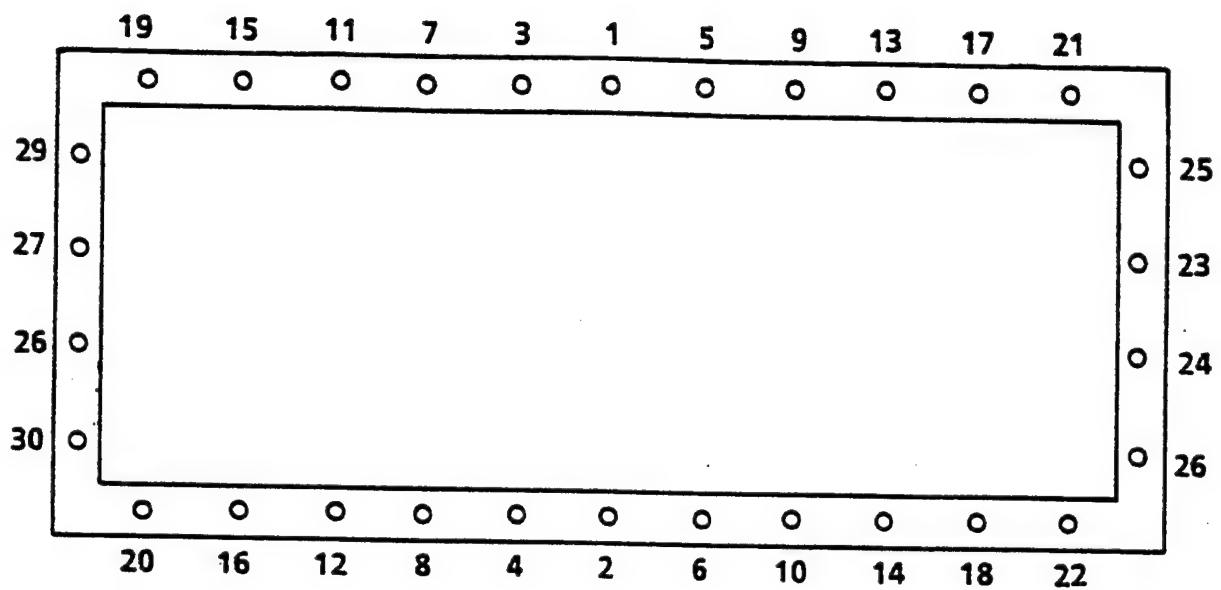
Figure 2-9. Optional tee bolt torquing sequence.

TEE BOLTS MAY BE TIGHTENED BY GOING AROUND THE CONTAINER IN EITHER DIRECTION, OR BY THE TORQUING SEQUENCE ILLUSTRATED ABOVE.
